PHILADELPHIA GAS WORKS

REQUEST FOR PROPOSALS

THE DEMOLITION OF THREE BUILDINGS

AND ASSOCIATED ITEMS LOCATED AT 3030 CASTOR AVENUE.

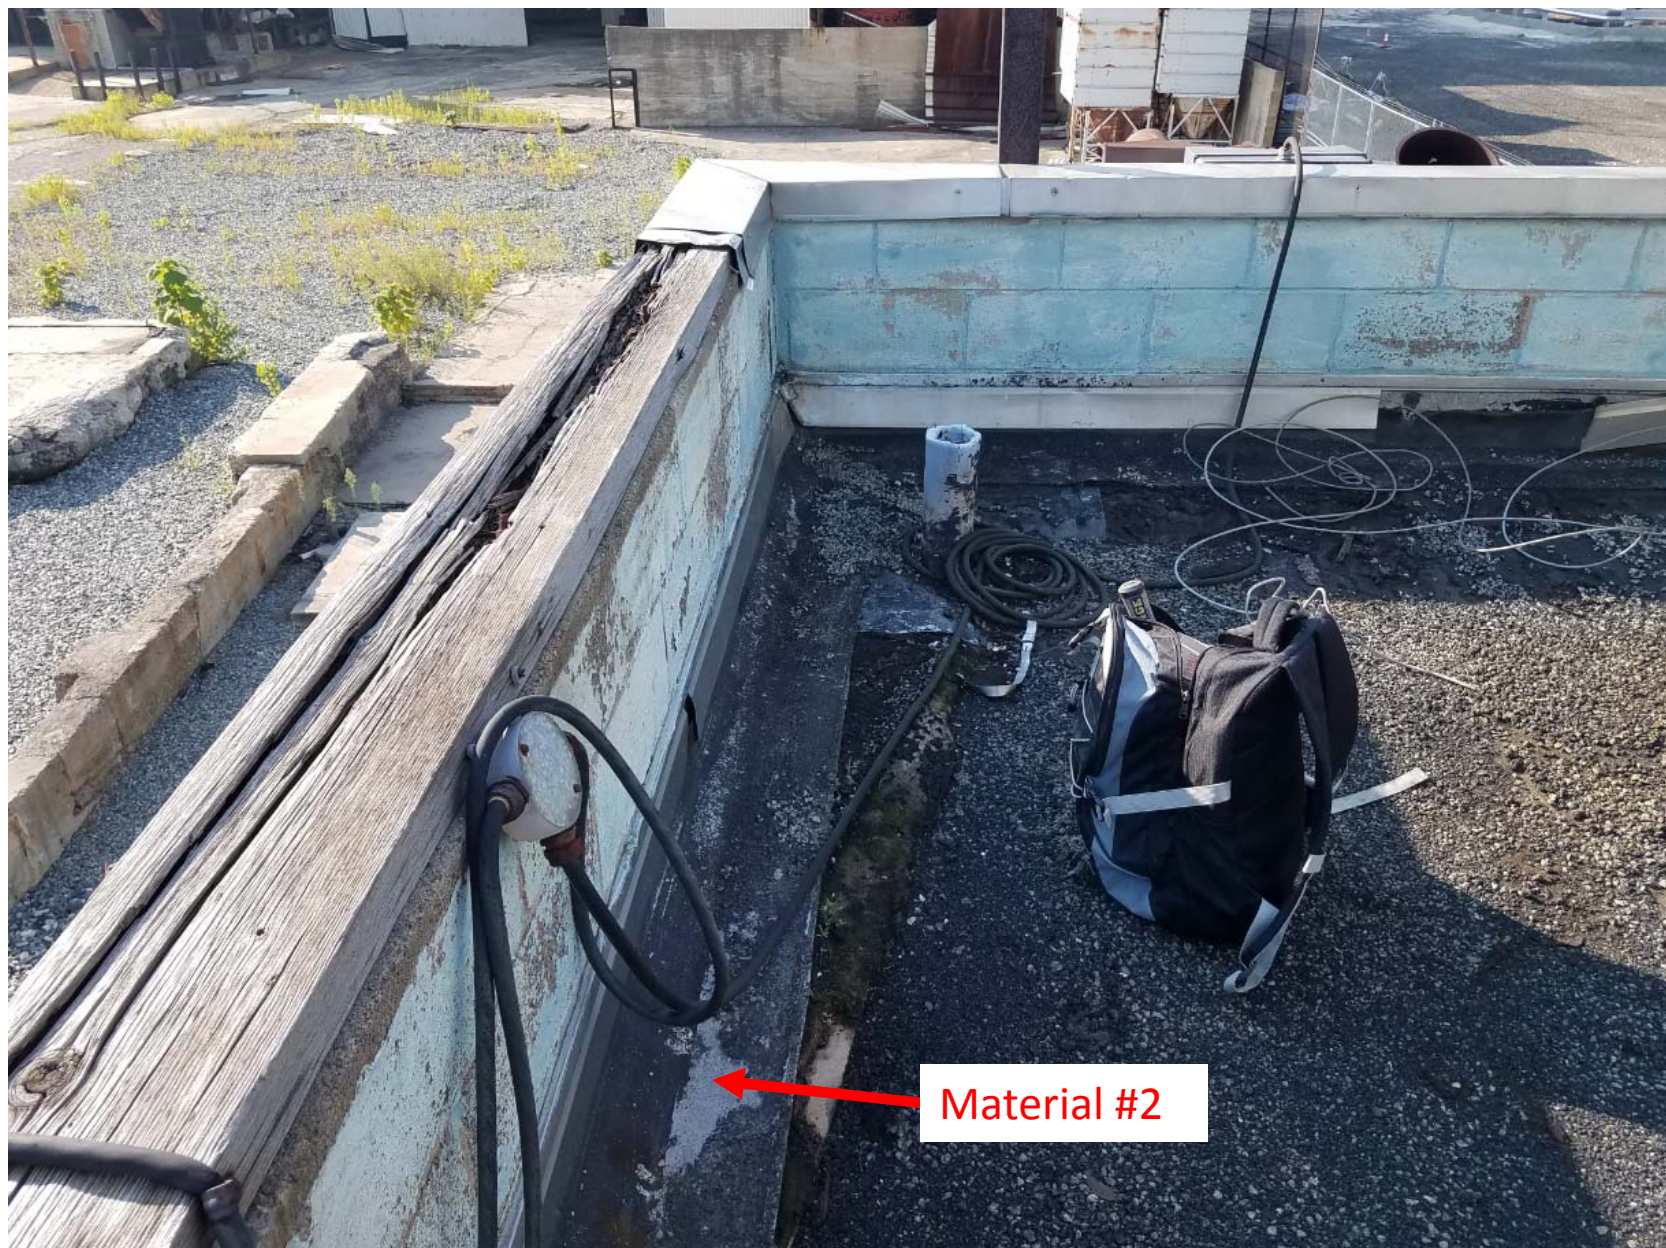
Photo 2: Northwest Building perimeter roof flashing close-up (Material #2).

Material #	Material	Category	Location(s) and Quantities	Friable (Y/N)	Condition	Sample Numbers	Confirmed ACM	Comments/Photo #
Confirmed and Presumed Asbestos Containing Materials								
2	Black Perimeter Roof Flashing	Misc.	Northwest Building, Roof Perimeter (180 SF)	N	Good	08102018-04 08102018-05 08102018-06	Yes (8.3% Chrysotile)	Black asphaltic felt roof flashing. See Photo #1.
3	Black Roof Flashing at Roof Penetrations	Misc.	Northwest Building, Roof Penetrations (60 SF)	N	Good	08102018-07 08102018-08 08102018-09	Yes (6.3% Chrysotile)	Black asphaltic felt roof flashing. Includes penetrations around pipe supports, air intakes, and electrical conduit. See Photos #1 and 2.
7	Gray-Black Roofing Cement/Tar	Misc.	Northwest Building, Roof Perimeter Seams and Roof Penetrations (Same Locations as Materials #2 and #3)	N	Good	08102018-19 08102018-20 08102018-21 08102018-11 (Layer 2)	Yes (8.2 - 15% Chrysotile)	See Photo #3. Some tar was adhered to silver caulk analyzed by IATL as Layer 2 of sample 08102018-11.

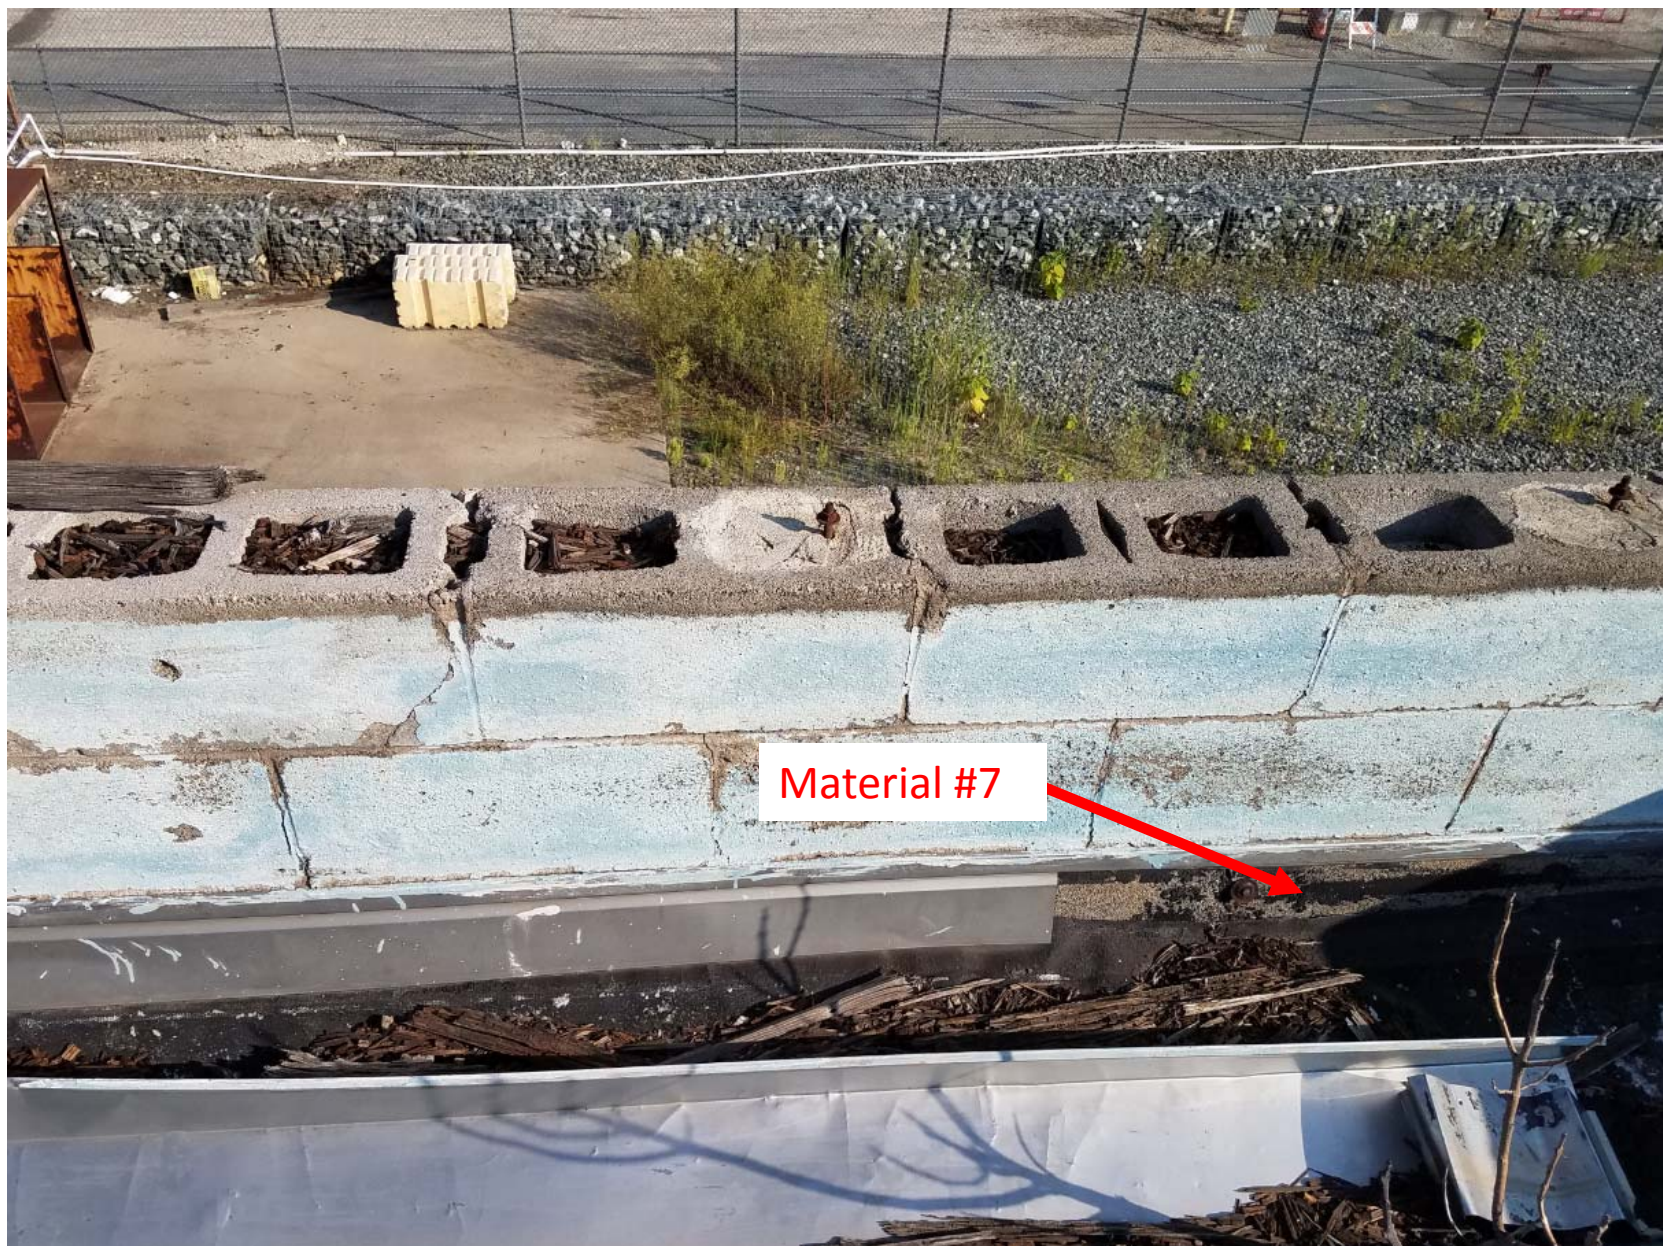
Photo 3: Northwest Building gray-black roofing cement (Material #7).

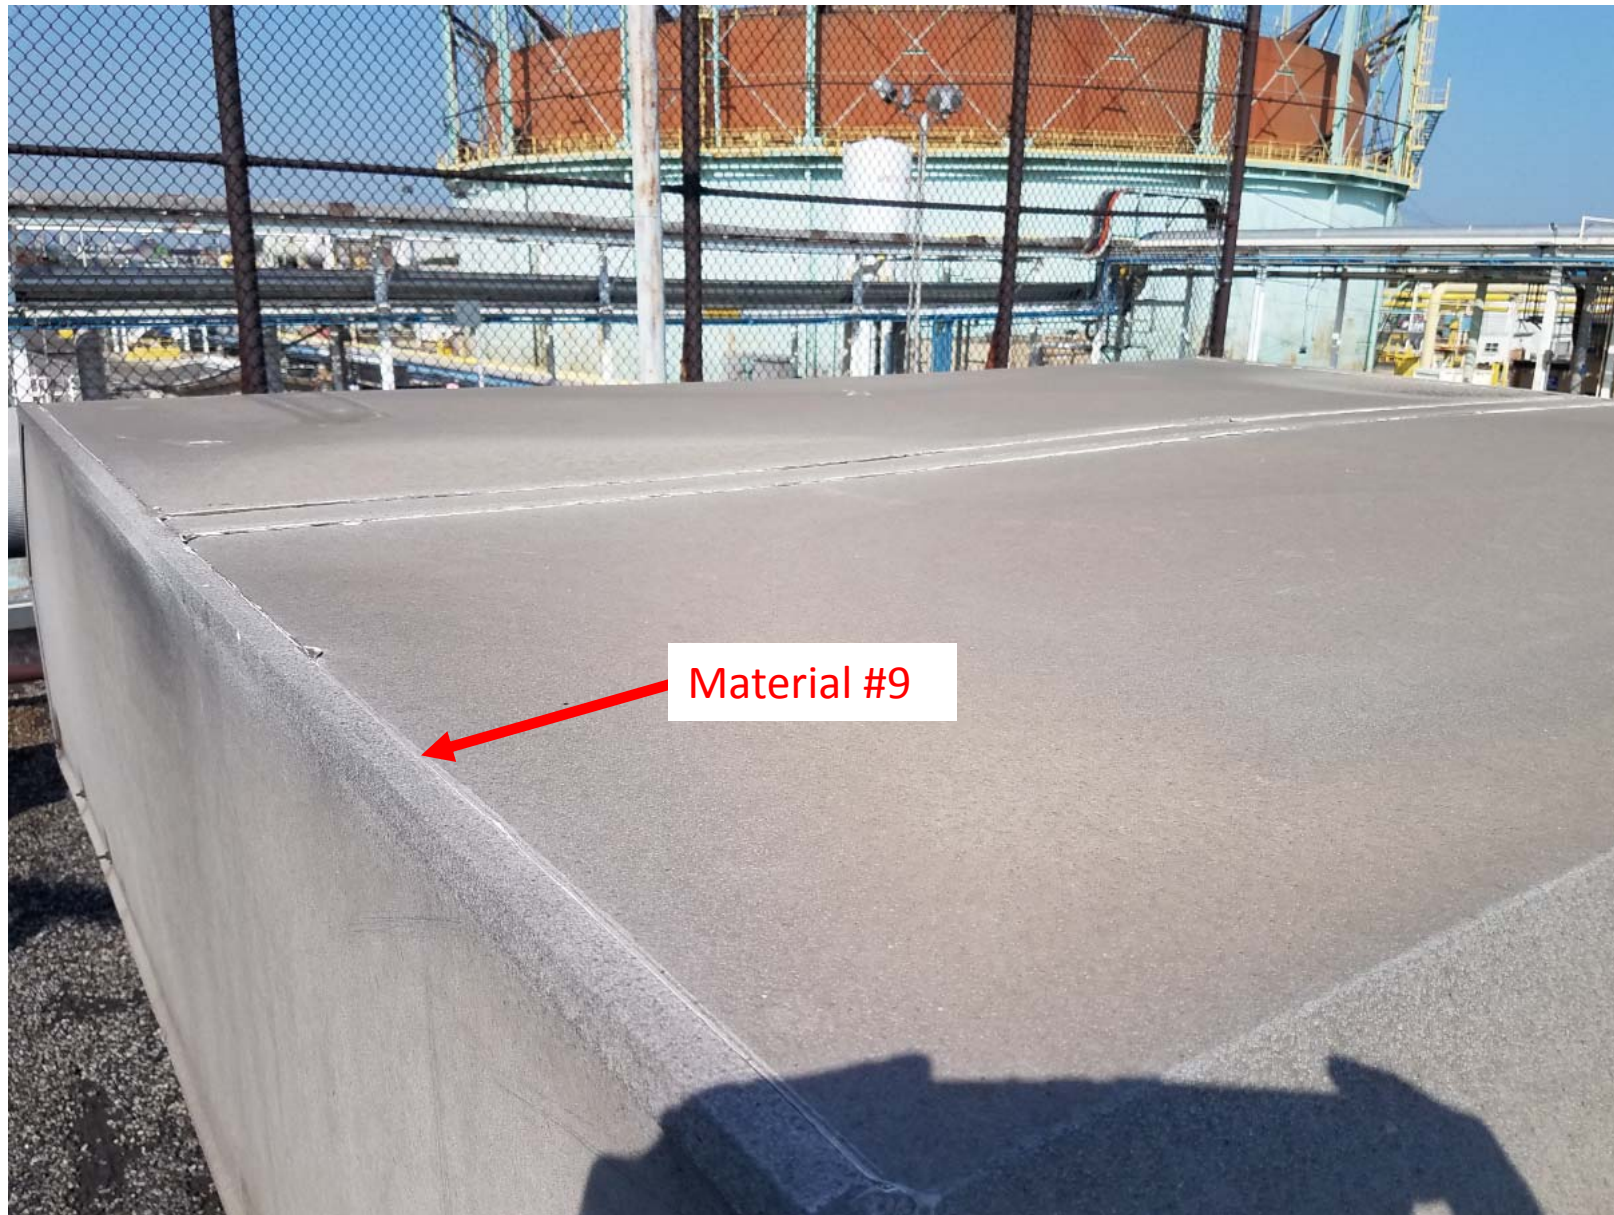
Photo 4: Norwest Building white caulk on air intake ductwork (Material #9).

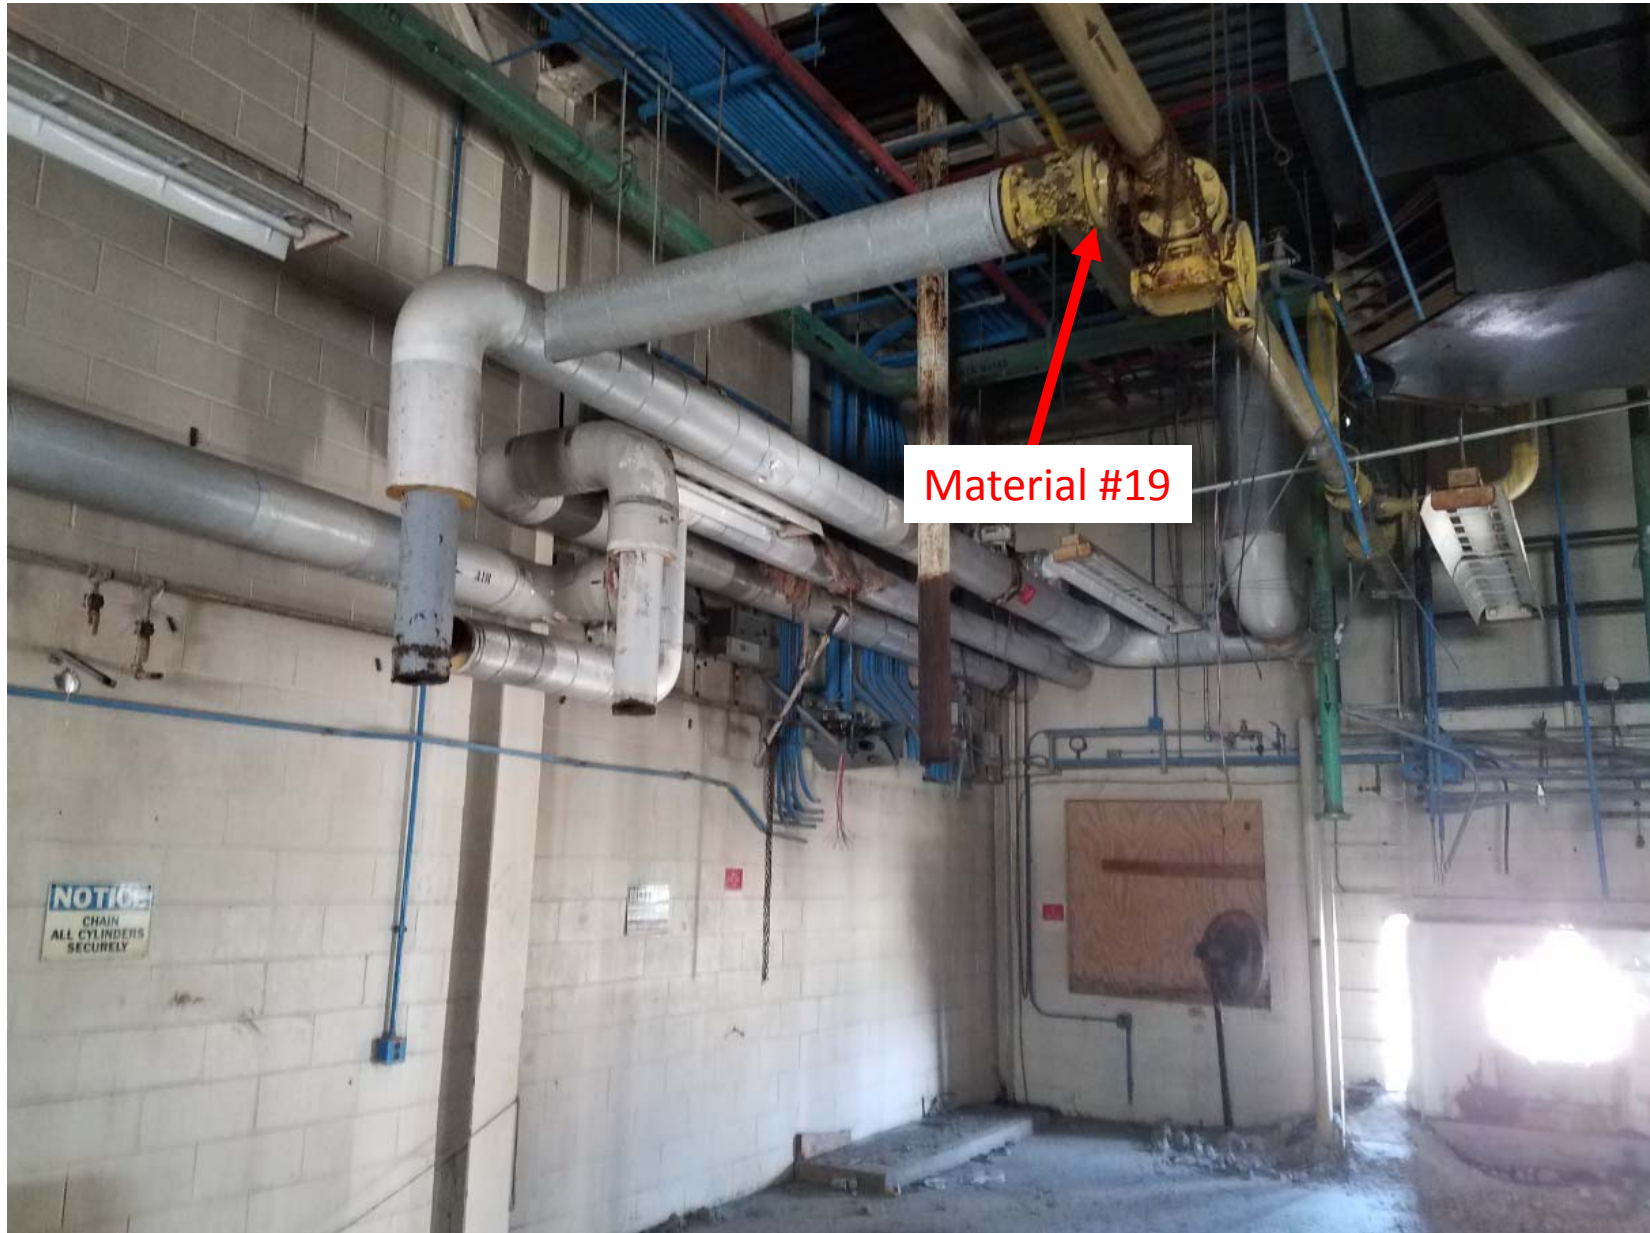
Photo 6: Northwest Building interior. Gaskets (Material #19) on all piping are ACM.

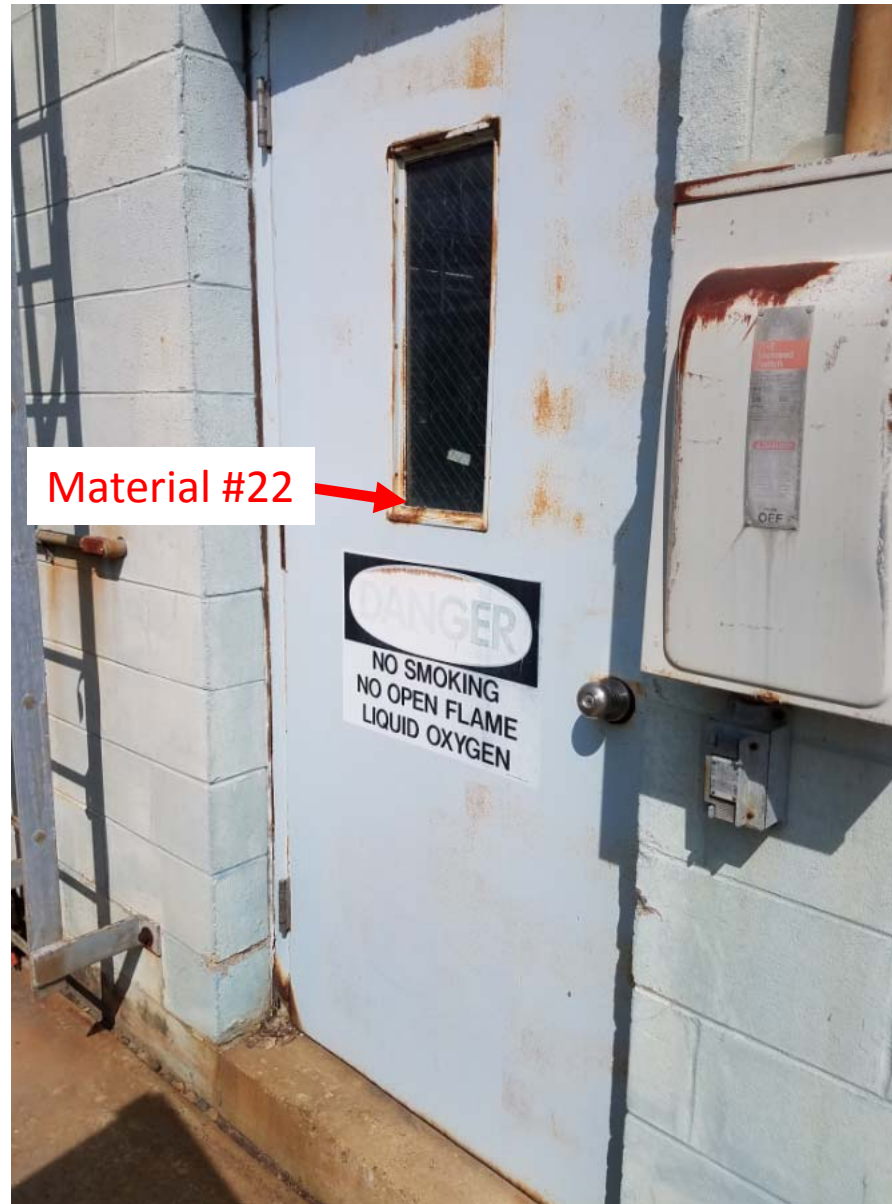
Photo 7: Northwest Building exterior door at south wall. Window glazing is ACM (Material #22).

Material #	Material	Category	Location(s) and Quantities	Friable (Y/N)	Condition	Sample Numbers	Confirmed ACM	Comments/Photo #
22	White Window Glazing	Misc.	- Northwest Building, Window Pane on Exterior Door at NE Corner (5 LF) - Northwest Building, Window Pane on Interior Door at NE Corner (5 LF) - Northwest Building, Window Pane on Exterior Door at South Wall (5 LF)	N	Good	08102018-60 08102018-61	Yes (1.2% Chrysotile)	See Photo #7.
23	Dark Gray-Black Gasket	Misc.	Main Building, Gaskets on Red Tank (5-10 gaskets; 5-10 SF)	N	Good	08102018-62 08102018-63	Yes (75% Chrysotile)	See Photo #9.
25	Fire Doors	Misc.	Main Building (2 doors)				Presumed	Fire doors locked; presumed to contain ACM insulation. See Photo #8.
32	White Woven Gasket	Misc.	Baghouse Adjacent to North of Main Building (Numerous Gaskets)	N	Good	08102018-81 08102018-82	Yes (80% Chrysotile)	Baghouse identified as Hopper Structure in IATL Sample Log. See Photo #10.

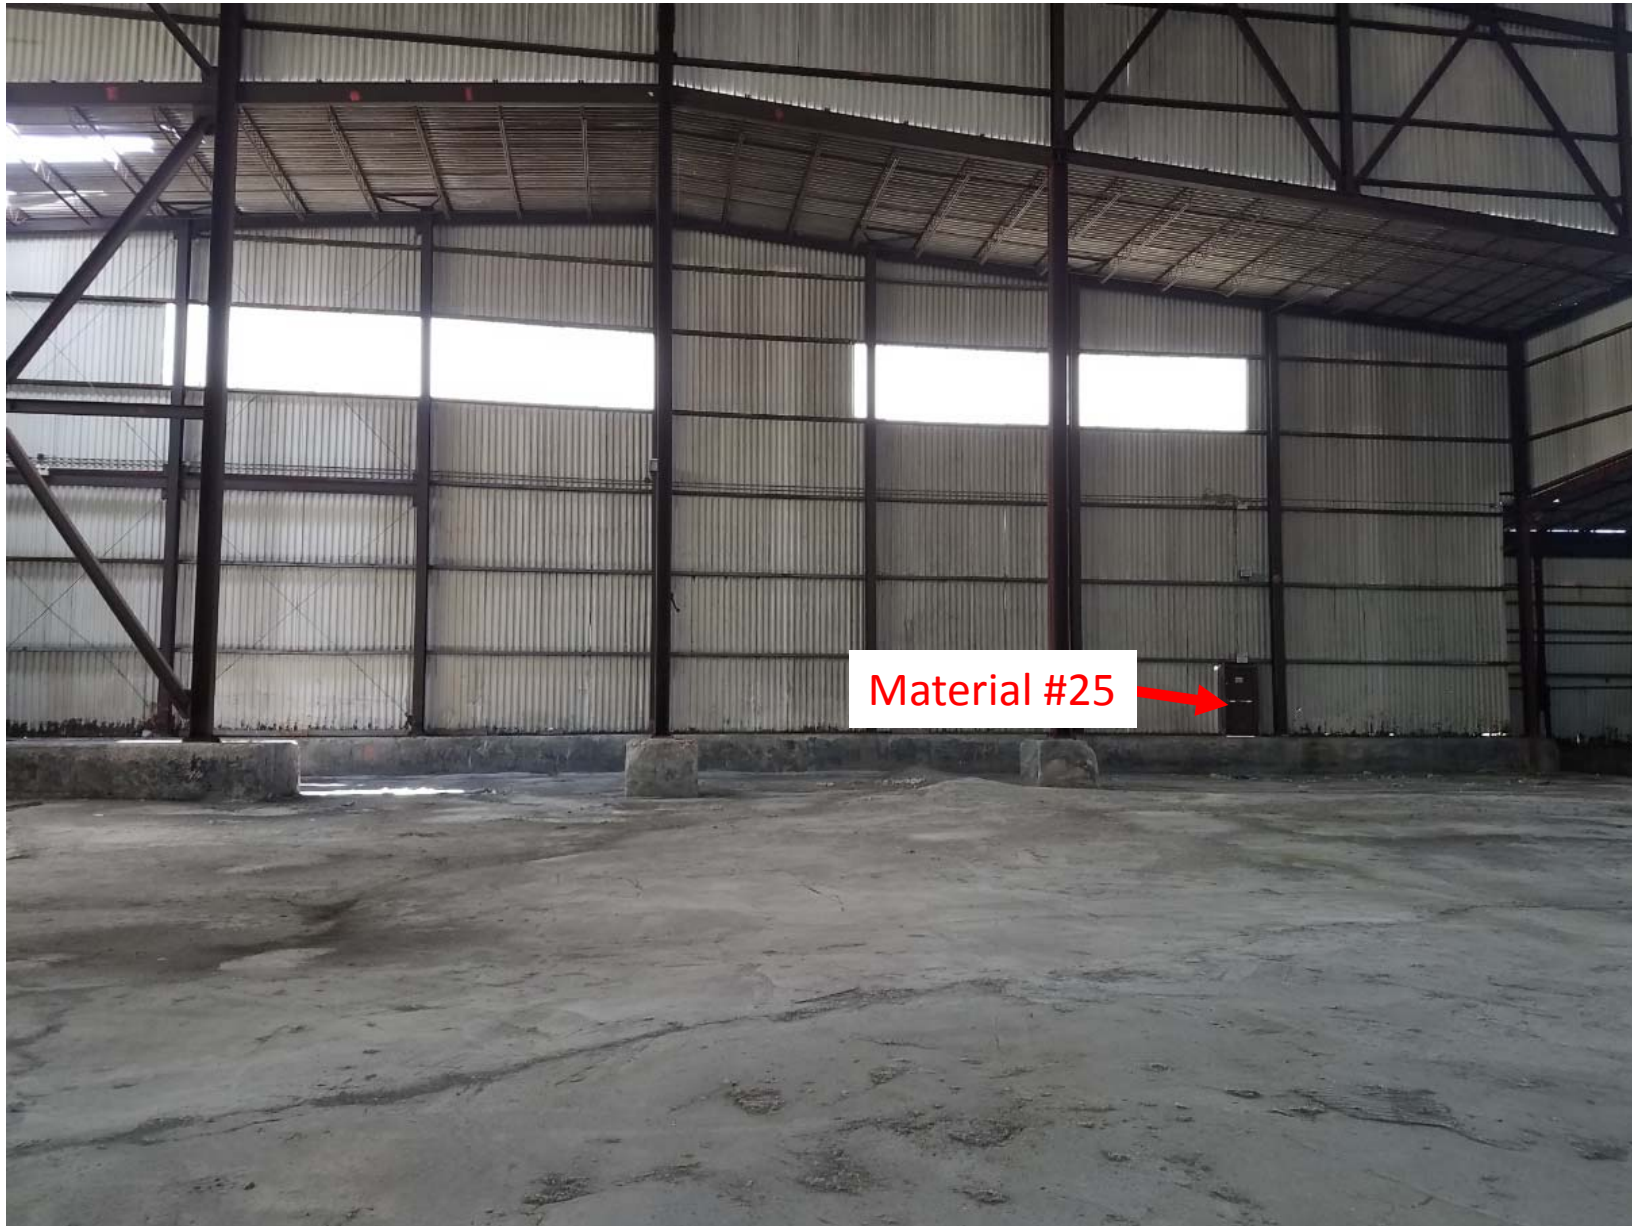
Photo 8: Fire doors observed within Main Franklin Smelting Building (Material # 25).

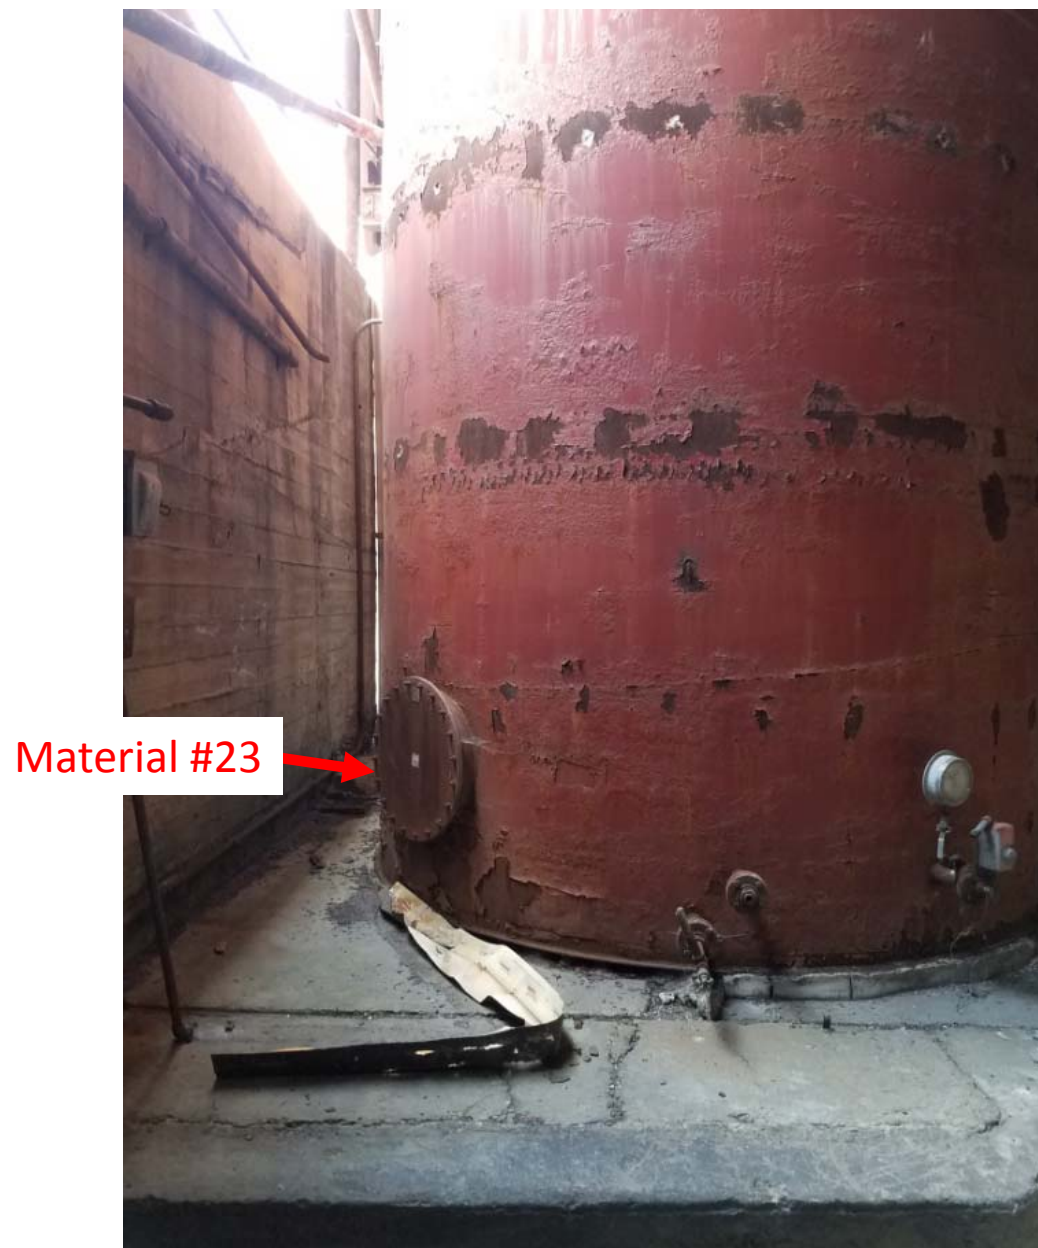
Photo 9: Asbestos-containing gaskets (Material #23) on red tank in NW corner of Main Building. Gaskets also observed on top of tank.

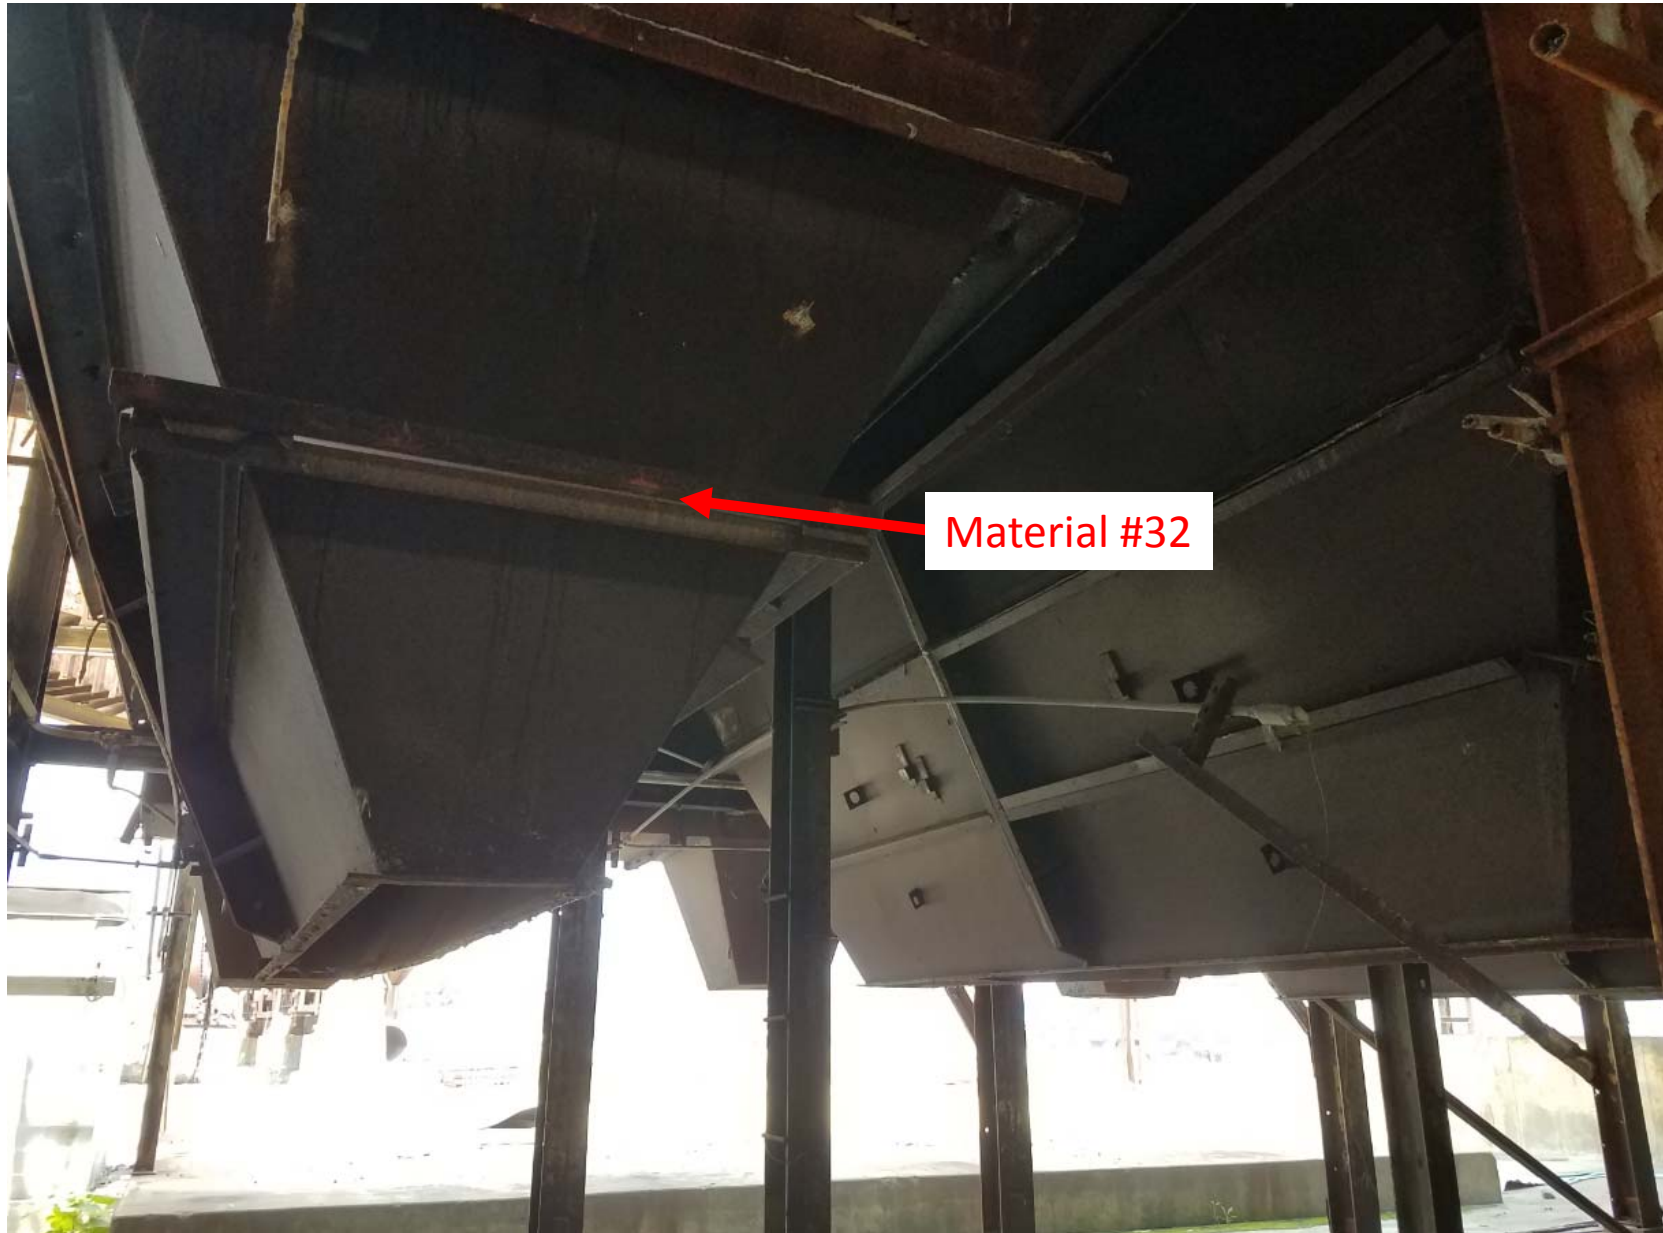
Photo 10: Asbestos-containing gaskets on baghouse adjacent to Main Building (Material #32).

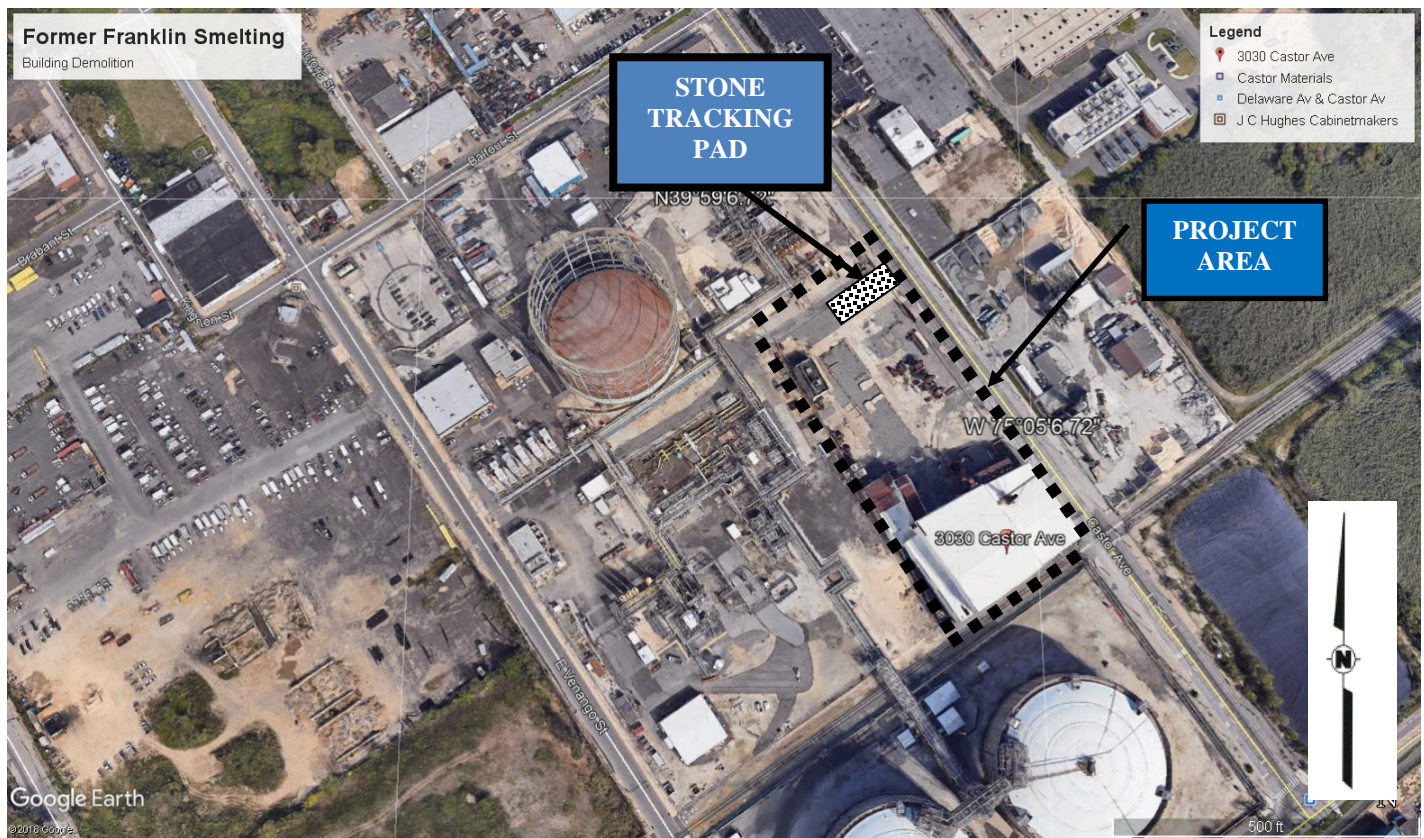
APPENDIX A

Erosion and Sediment Control Site Plan & USGS Topographic Map

- 2.17 The Contractor shall protect all inlets and drains on the property with a compost sock or synthetic filter. The inlet protection shall be installed, inspected, cleaned and replaced according to manufacturer's specifications.

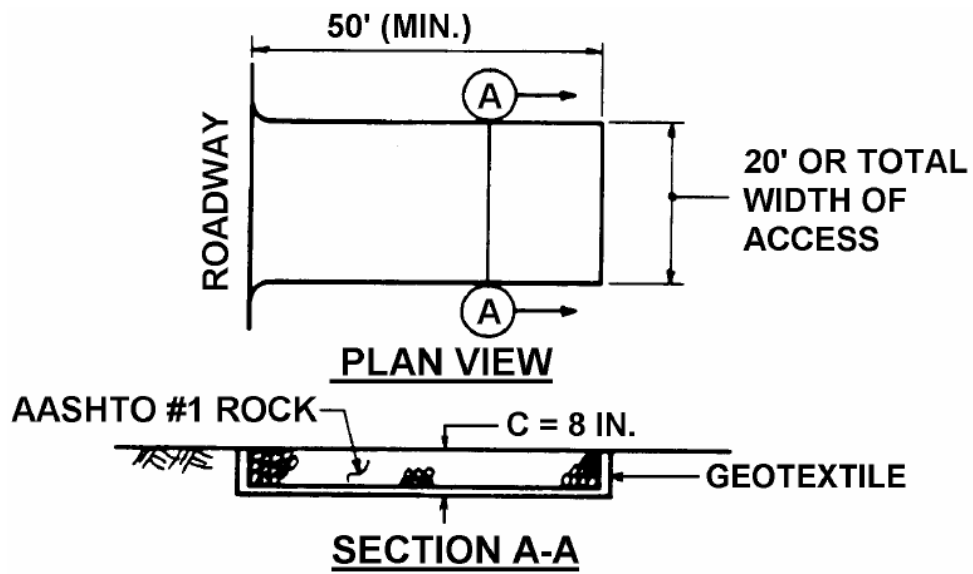
STANDARD CONSTRUCTION DETAIL #16
Rock Construction Entrance
